SNETTISHAM

CRATER LAKE - ALASKA

SECOND STAGE DEVELOPMENT

FINAL FOUNDATION REPORT

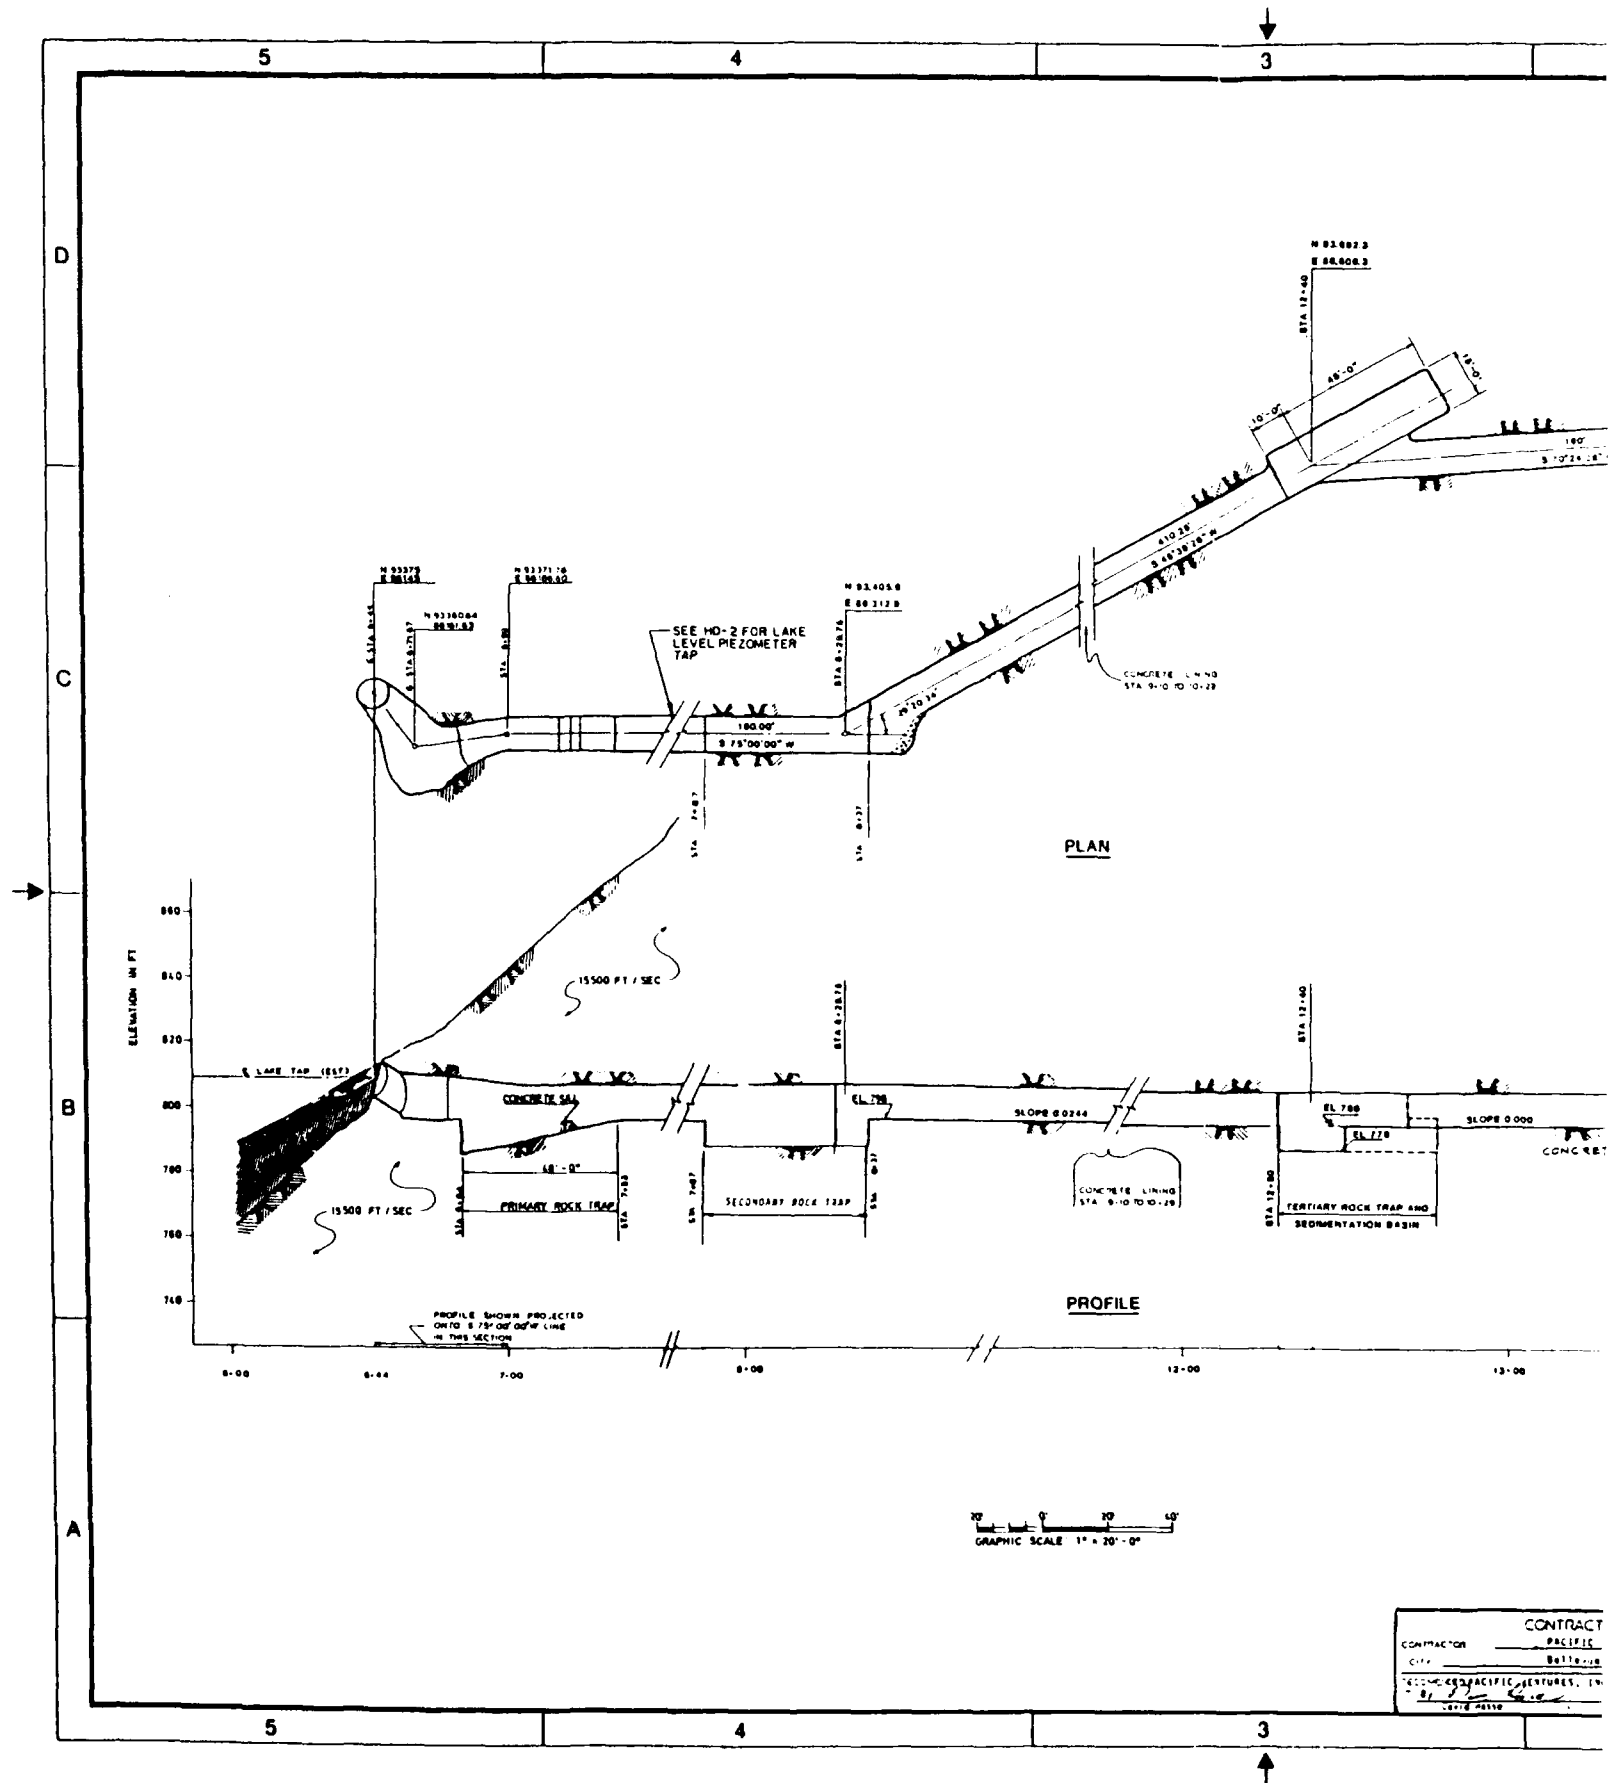
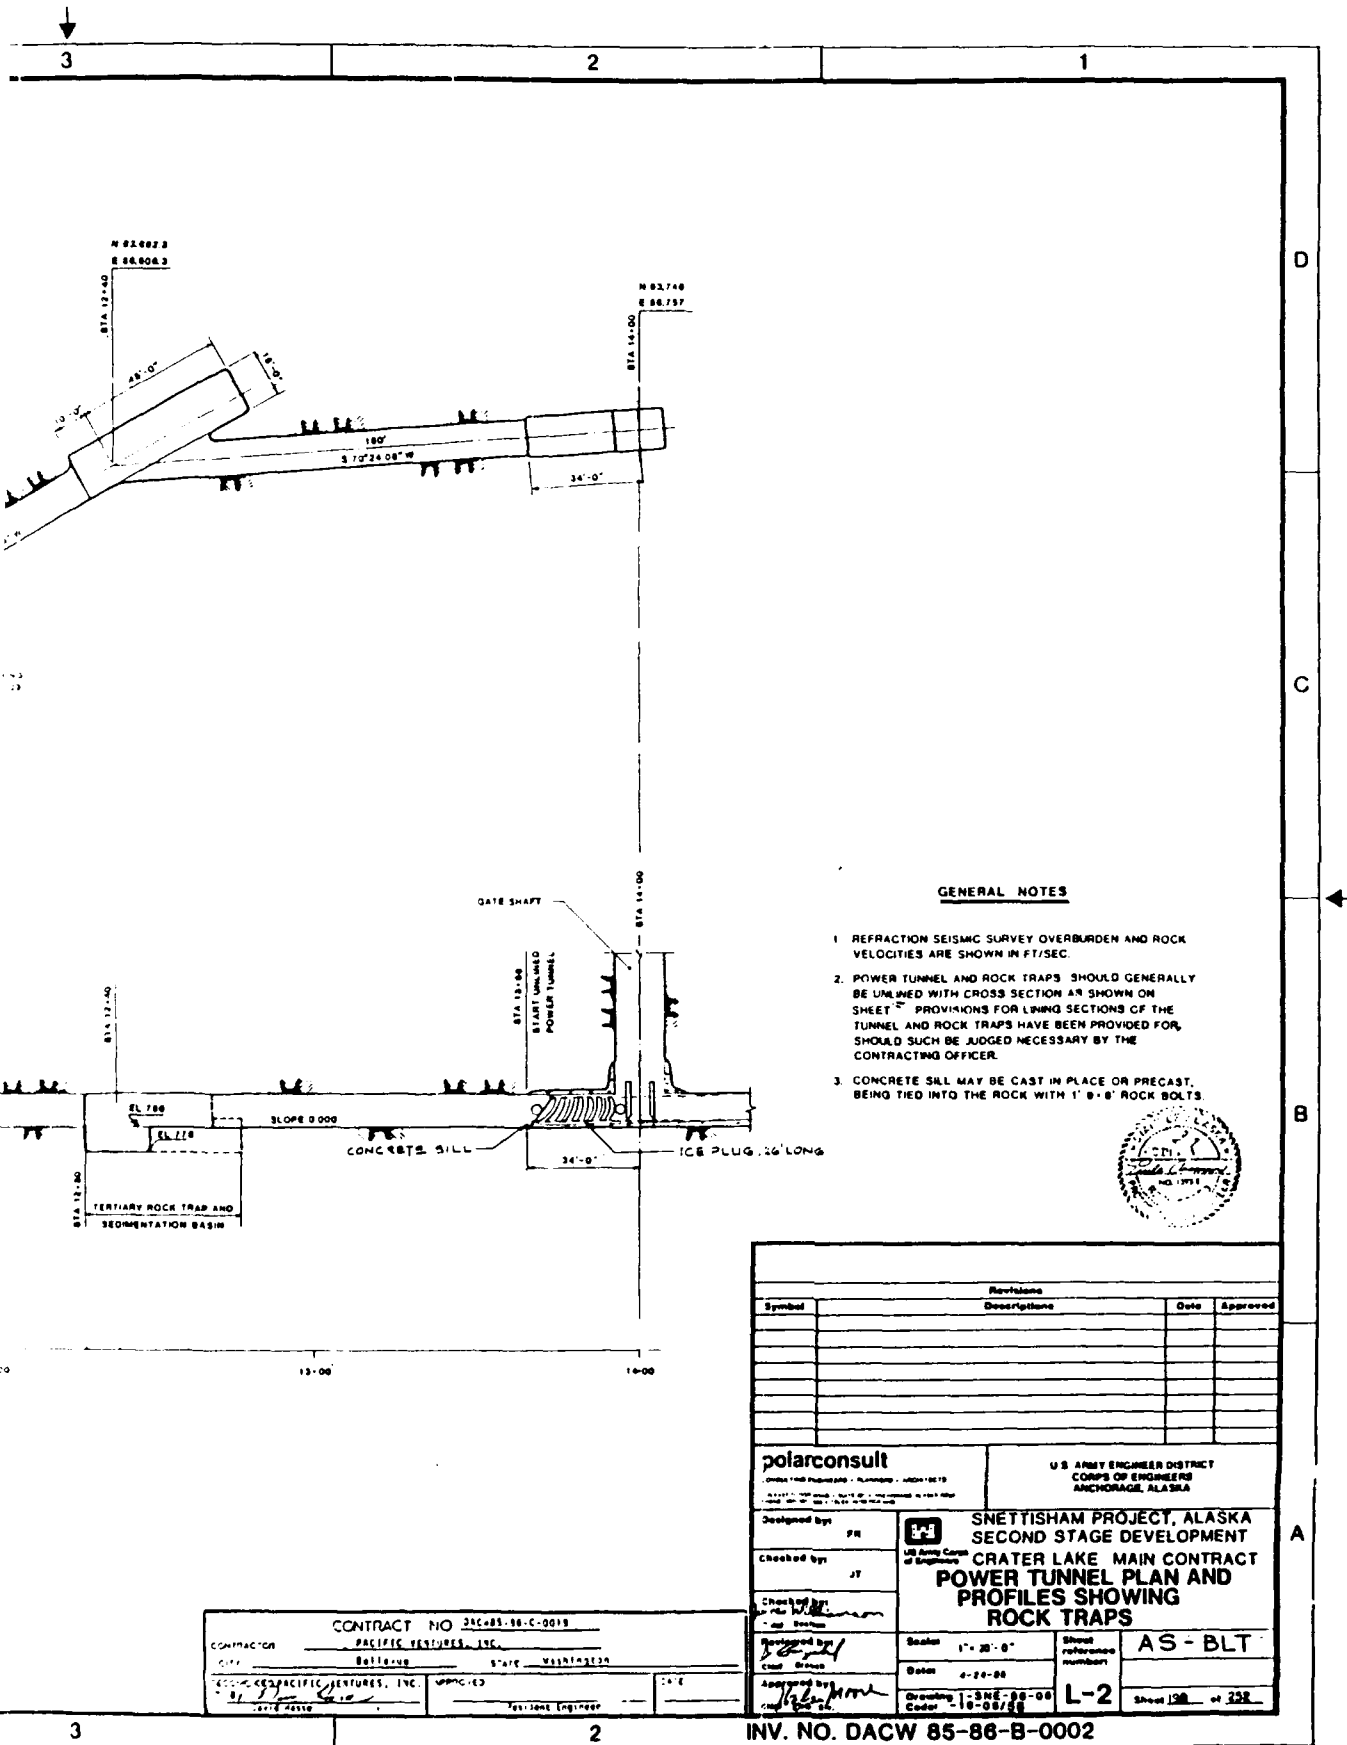
FIGURE A-8

Lake tap modifications became necessary because of unfavorable rock conditions encountered at the location of the secondary rock trap, and because of the configuration of the lake bottom at the point of the tap. The rock encountered in the left wall at the proposed secondary rock trap was composed of highly fractured pegmatite similar to that encountered at the Hilltop-Cliffside Shear Zone (see discussion below). For this reason, the secondary rock trap was moved upstream and deepened. See Figure A-8 for details of the as-built rock trap.
